ENGINEERING GEOLOGIC REPORT

Proposed Lot Line Adjustment
140 Conejo Road and 180 Conejo Road
Santa Barbara, California

July 27, 2008

File No. GC07-102266

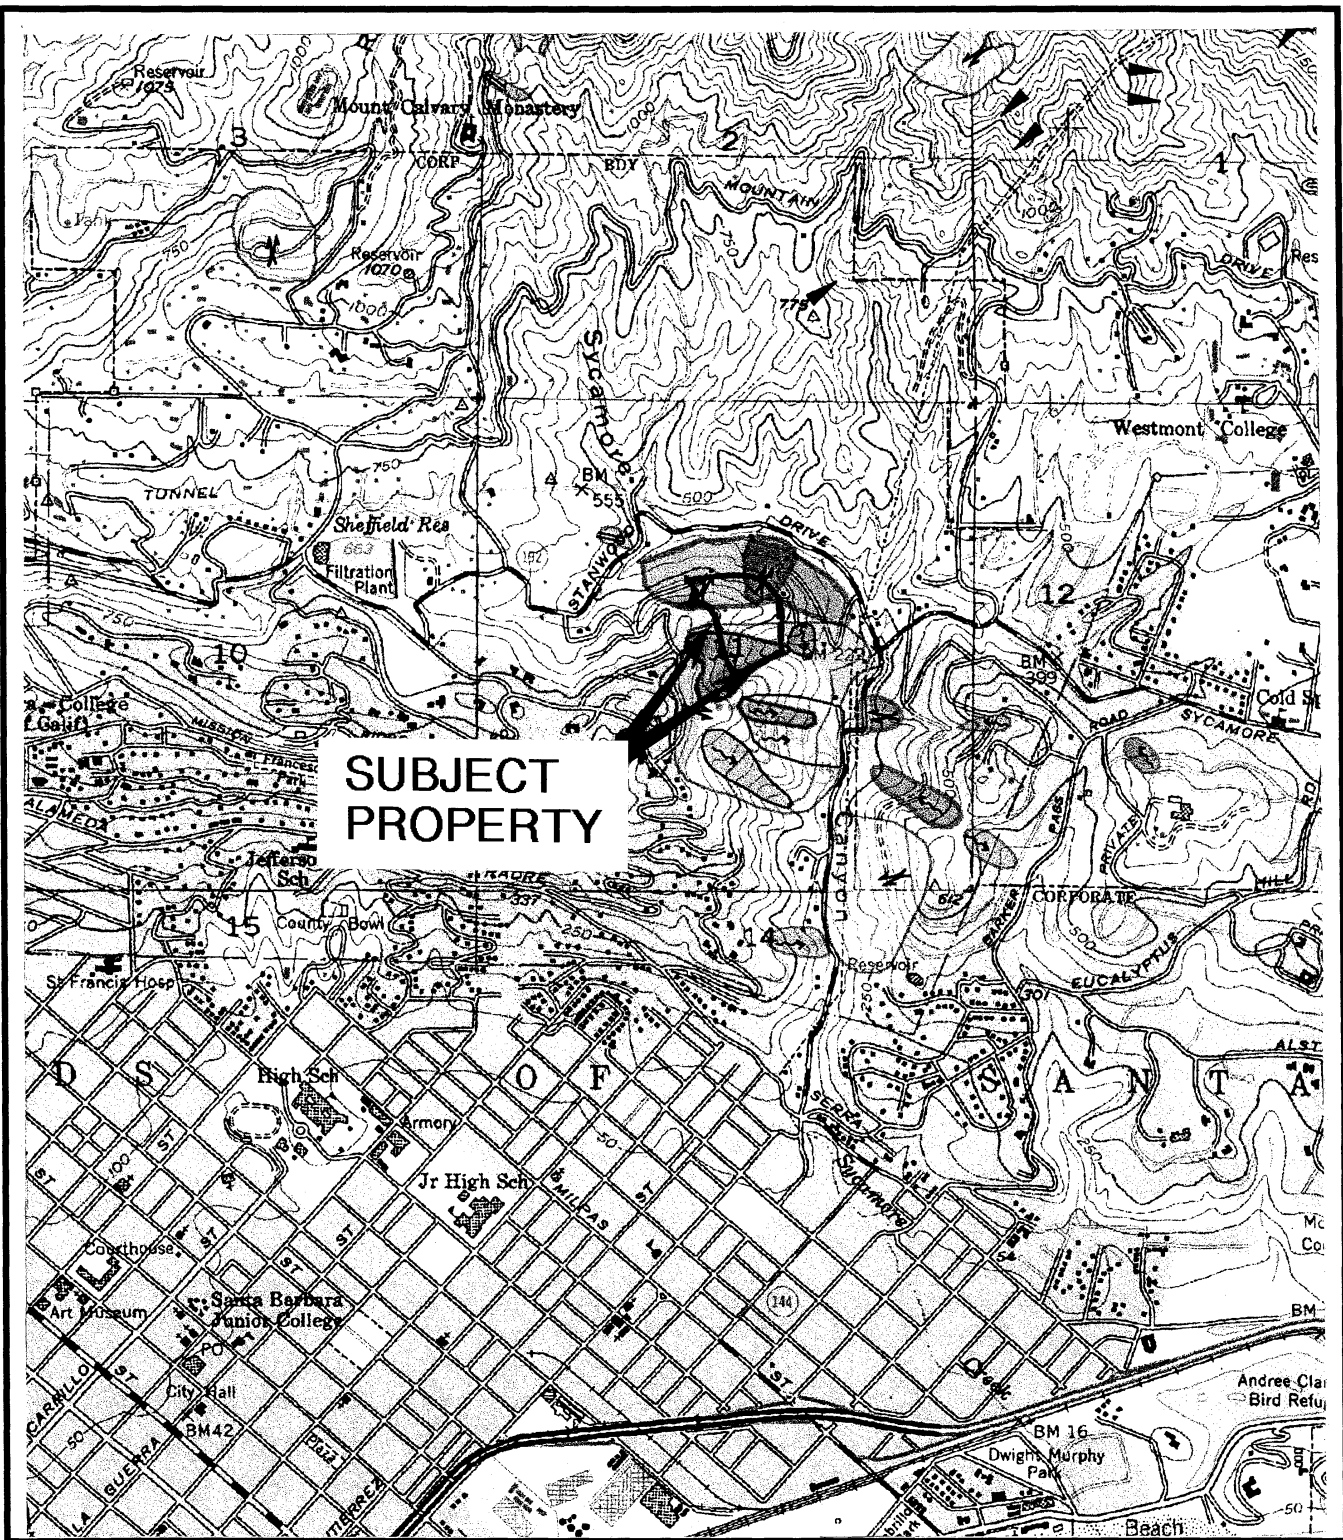
BASE MAP: DMG OPEN FILE REPORT 99-12, PLATE 2B (2000)
 LANDSLIDE HAZARD MAPS OF SOUTHERN SANTA BARBARA COUNTY, CALIFORNIA

The *Landslide Hazard Maps of Southeastern Santa Barbara County, California* (DMG Open-File Report 99-12, 2000) show landslides within and adjacent to the property (see Figure 3). The mapped landslides are designated as either dormant or as "active or historic". The landslide limits shown on the 2000 DMG map were established on the basis of their "landforms", as determined by observation by a field geologist or by aerial photographic interpretation by a geologist. The mapped landslide areas were not verified by subsurface exploration. The text with the maps indicated that a site-specific investigation by an engineering geologist is required to evaluate landslide hazard potential.

Geomorphologic indicators of soil slippage and/or shallow soil slumps, including hummocky terrain and low, approximate 2-4 foot high scarps, are evident along the lower slope area at the north-northeast side of Proposed Adjusted Parcel Two and at the east-southeast side of Proposed Adjusted Parcel One. The soil slip areas are indicated on the Plot Plan / Geologic Map with this report. No geomorphologic evidence of deep landslide movement was observed, and no evidence of deep landslide movement was encountered during downhole geologic logging of the exploratory borings for this investigation.

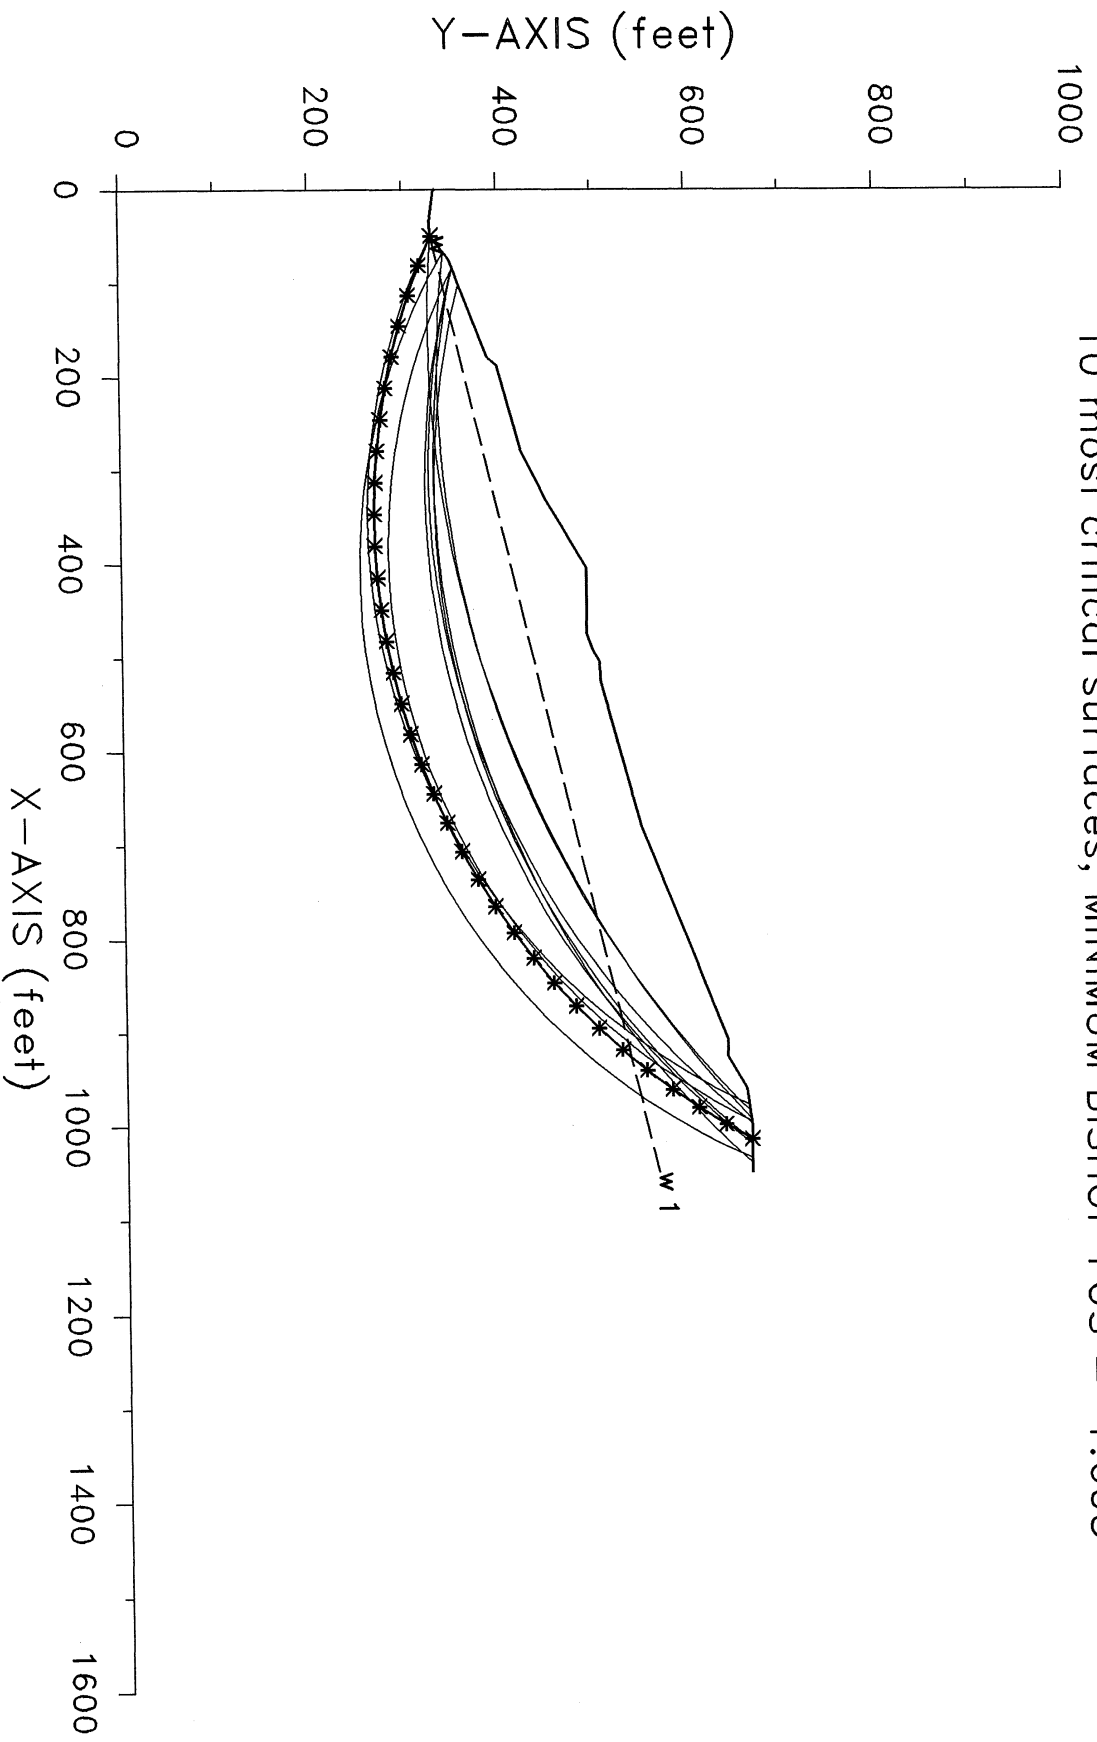
140 CONEJO RD, SB, SEC-A, GRS-CR,STT
10 most critical surfaces, MINIMUM BISHOP FOS = 1.605

The results of the slope stability analysis indicate that the safety factors against deep-seated slope failure exceed the minimum accepted static safety factor of 1.5. The factors of safety exceed the minimum pseudo-static or seismic safety factor of 1.1 in consideration of seismically-induced landslide hazard potential. The calculated factors of safety are considered to be adequate for the proposed development area within Proposed Adjusted Parcel Two.

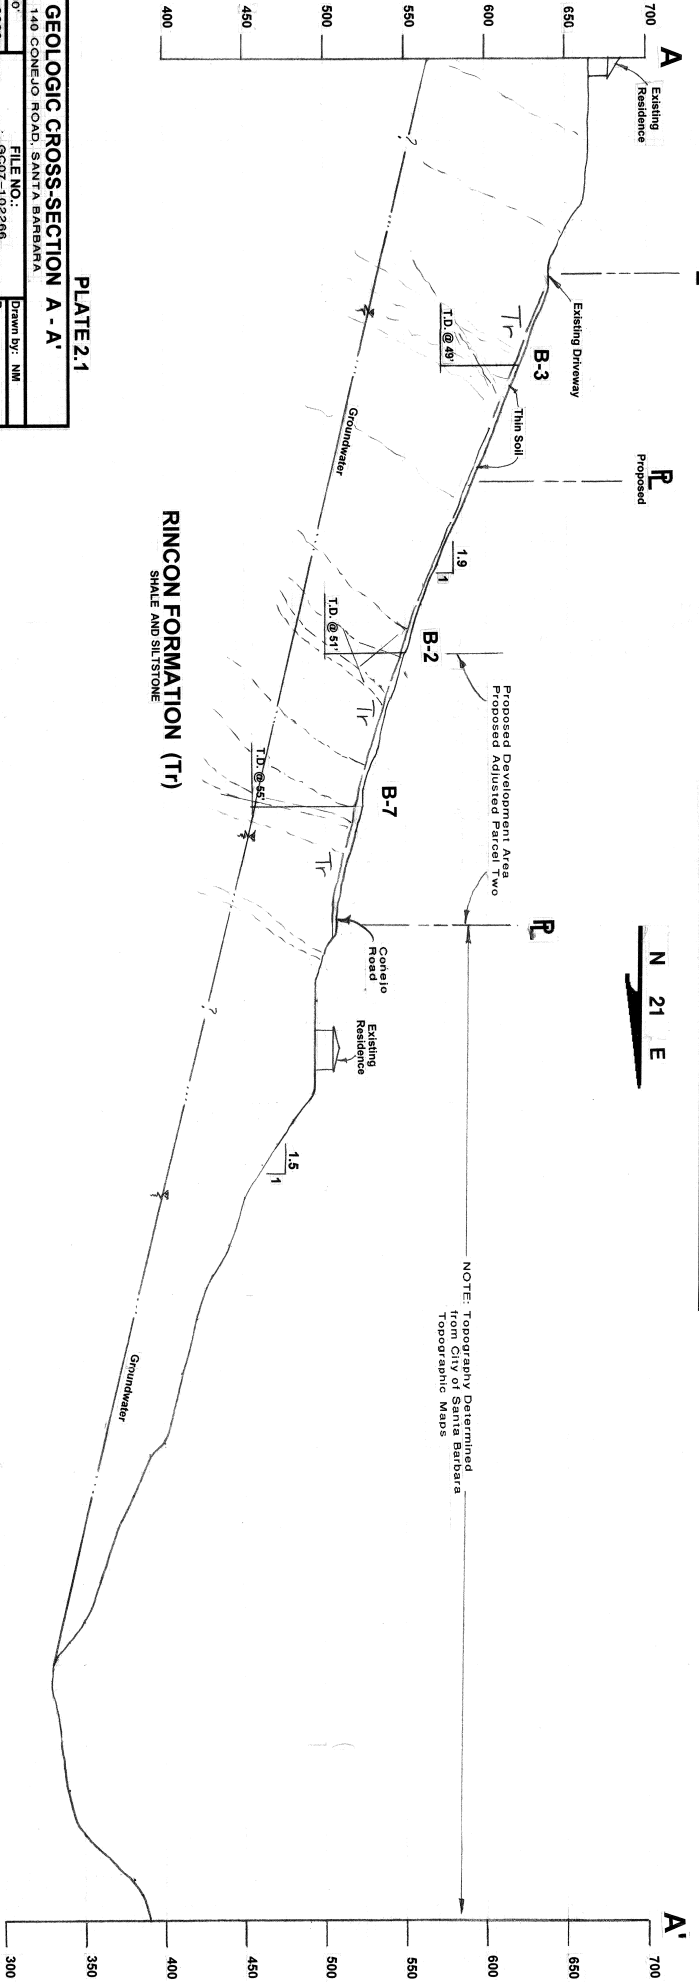
PLATE 2.1

The factors of safety against slope failure were determined using the XSTABL slope stability computer software program. The slope stability analysis was performed along Geologic Cross-Section A-A', assuming circular failure mode for all cases. The XSTABL program presents the 10 most critical failure planes in the output file. The output file has

a summary of the input file and the coordinate of several points on the most critical failure plane. The most critical failure surfaces that yield the lowest factors of safety for each cross-section determined from the analysis are plotted onto the Geotechnical Cross-Section with this report.

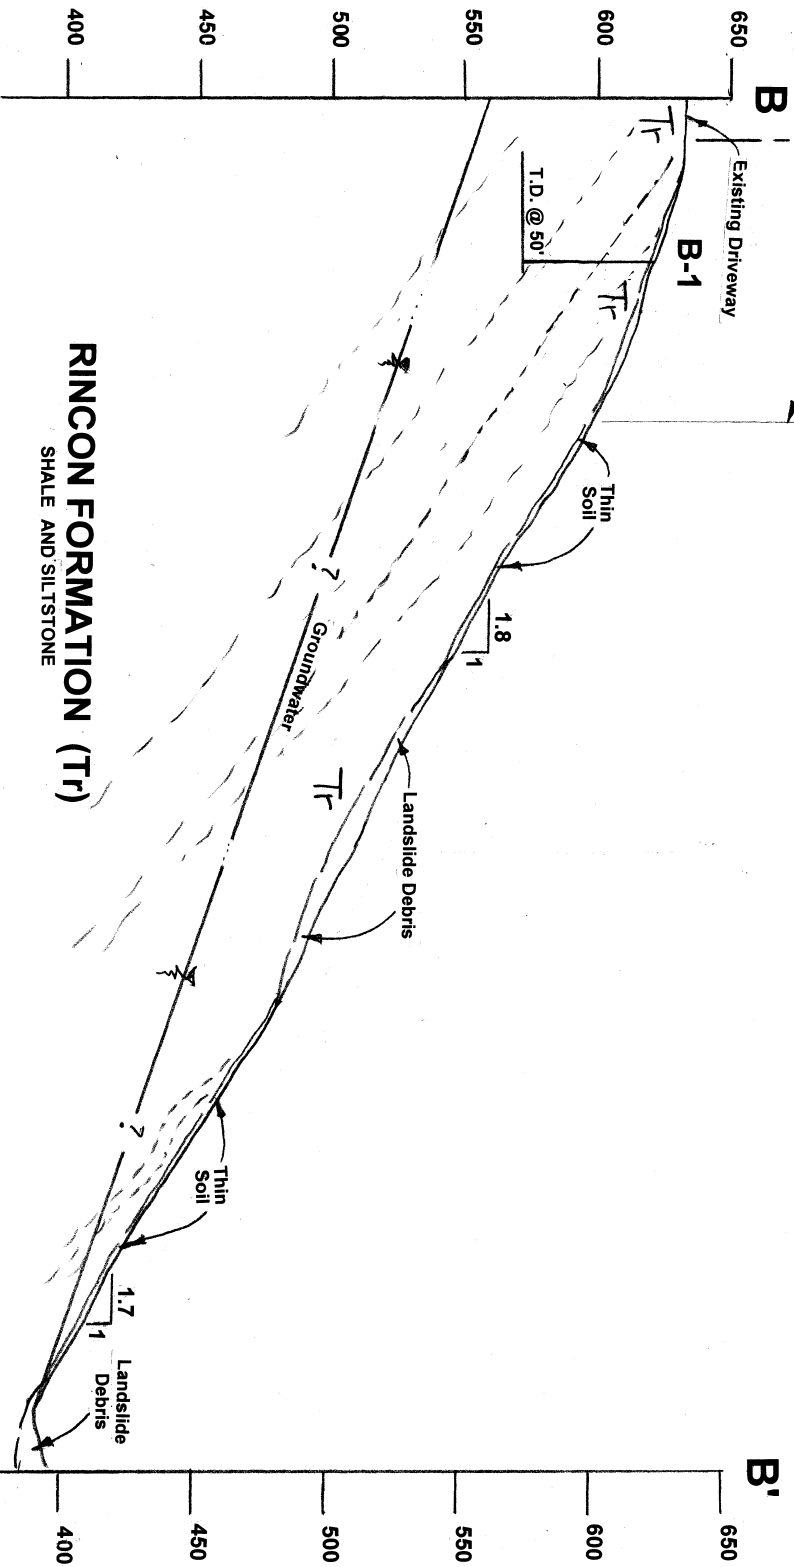
PLATE 2.2

The slopes within the canyon at the south side of Proposed Adjusted Parcel One do not have adequate factors of safety against seismically-induced landslide hazard. A "Restricted Use Area" is recommended within the canyon at the south side of Proposed Adjusted Parcel One due to the seismically-induced landslide hazard potential in this area. Special studies will be required by an engineering geologist and/or a geotechnical engineer to provide recommendations for mitigation of landslide hazards if any future development is proposed within the "Restricted Use Area".

The slopes within the canyon at the south side of Proposed Adjusted Parcel One do not have adequate factors of safety against seismically-induced landslide hazard. The slopes along the north-northeast side of Proposed Adjusted Parcel Two show evidence of soil slippage within the areas shown on the Plot Plan / Geologic Map with this report. A "Restricted Use Area" is recommended within the slope areas at the south and east sides of Proposed Adjusted Parcel One, and along the north side of Proposed Adjusted Parcel One and Proposed Adjusted Parcel Two due to the seismically-induced landslide hazard potential and soil slip hazard potential in this area of the property. The recommended "Restricted Use Area" is shown on Plate 1.2 with this report. Special studies will be required by an engineering geologist and/or a geotechnical engineer to provide recommendations for mitigation of landslide hazards if any future development is proposed within the "Restricted Use Area".
